Property Inventory and Condition Survey
for the
Group IV Utility Systems Property

and
Group II Chemical Plant Property
within the

Shell Oil Company Leasehold Area
at
US Army Rocky Mountain Arsenal
Commerce City, CO.

VOLUME THREE

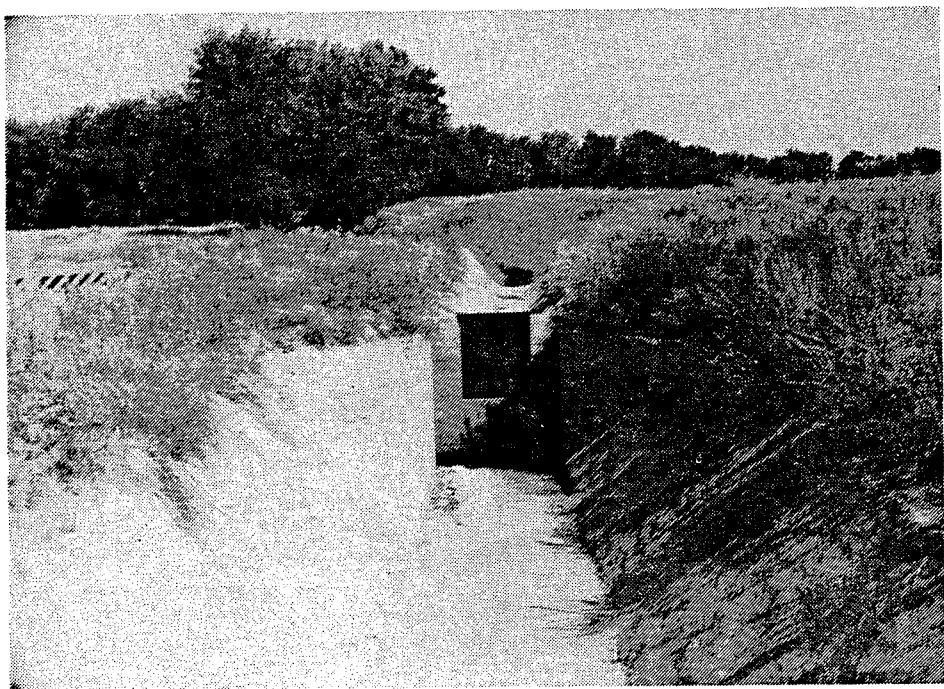
MEASURING STATION: South of 6th
Avenue (Looking South)
Date of Photograph: 3 September 1982

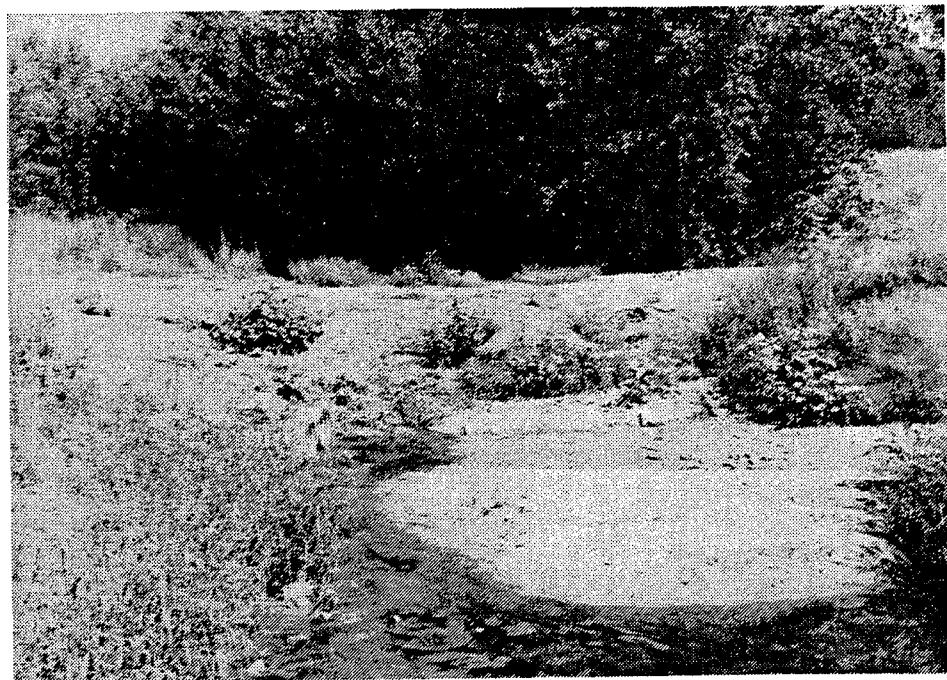
DIVERSION STRUCTURE FROM HIGHLINE
CANAL (Erosion) (Looking East)
Date of Photograph: 3 September 1982

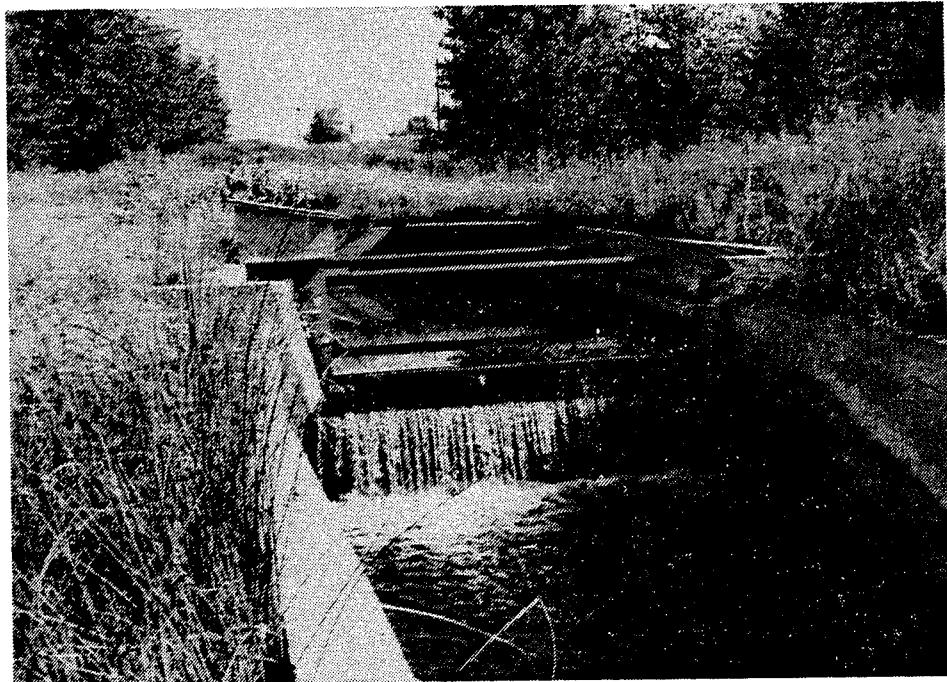
MONTBELLO CANAL: Block and
Diversion To Lower Derby Lake
Date of Photograph: 3 September 1982

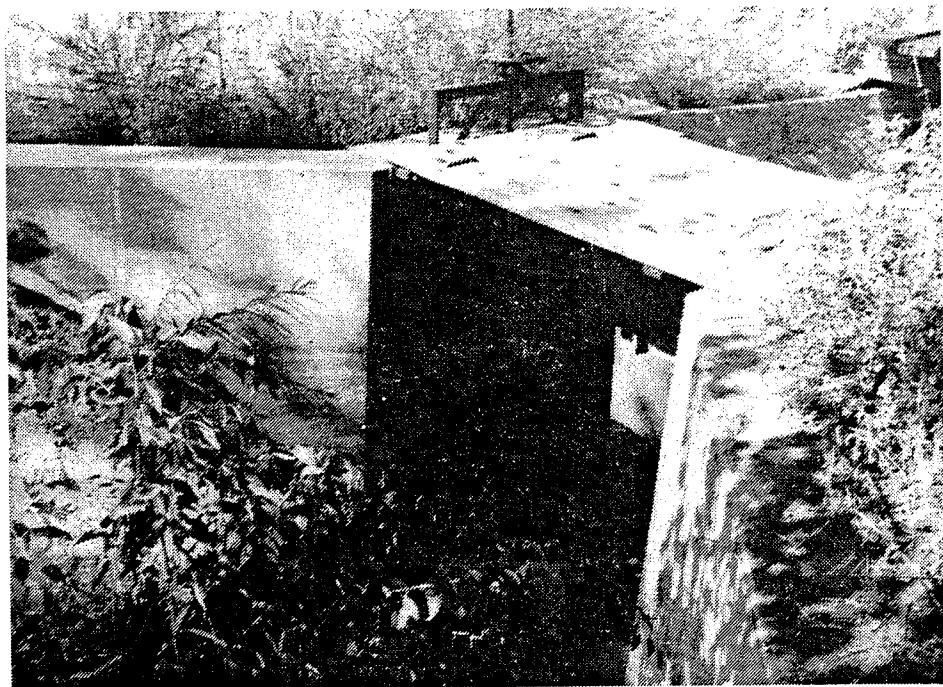
DIVERSION CHANNEL FROM UPPER
DERBY OUTFALL TO LADORA LAKE
Date of Photograph: 3 September 1982

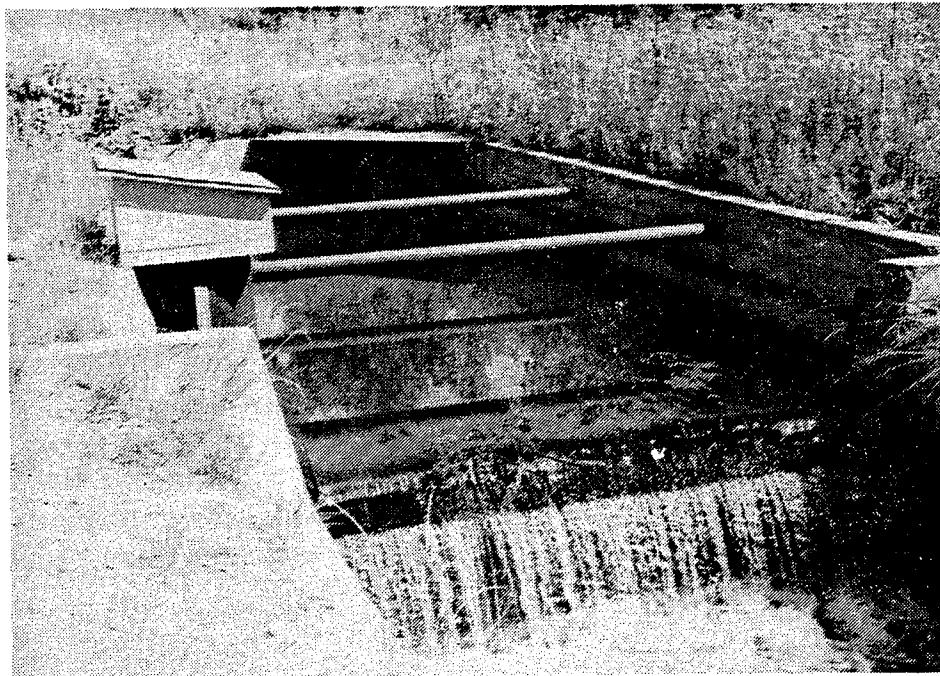
Diversion Box from Upper
Derby
Date of Photograph: 7 September 1982

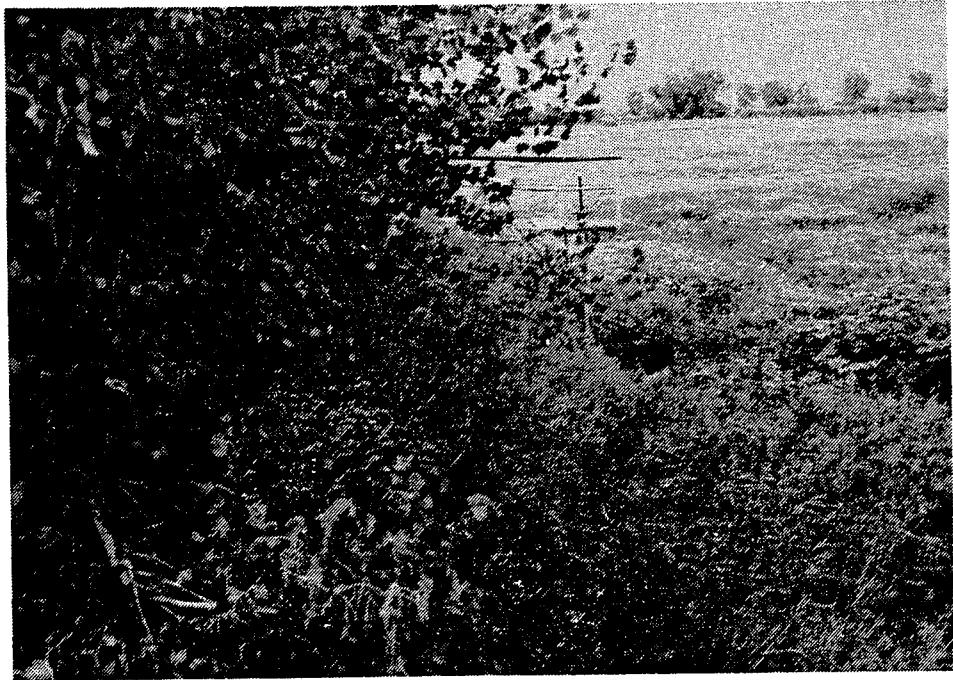
DIKE BETWEEN LOWER AND UPPER
DERBY LAKE: Looking North
Date of Photograph: 26 August 1982

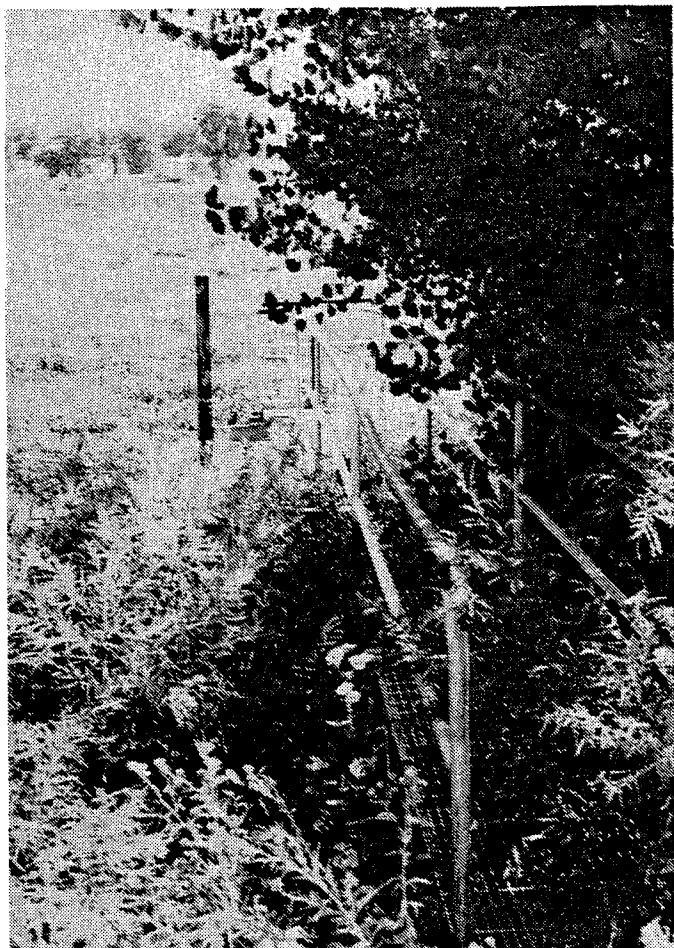
UPPER DERBY LAKE: Sluice Gate
and Riprap
Date of Photograph: 26 August 1982

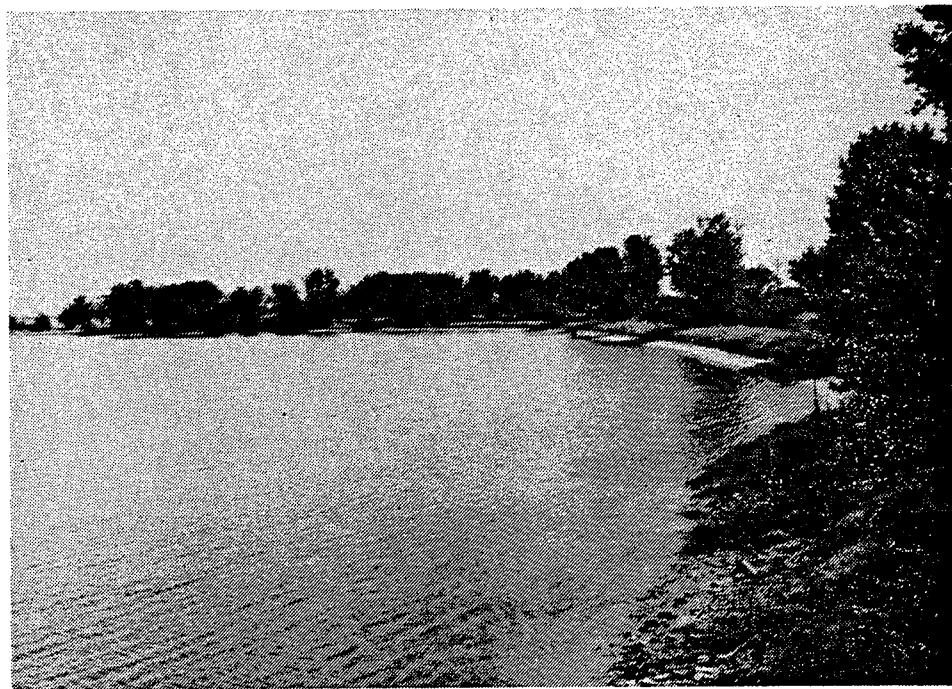
UPPER DERBY LAKE AND OUTFALL
STRUCTURE (Abandoned)
Date of Photograph: 3 September 1982

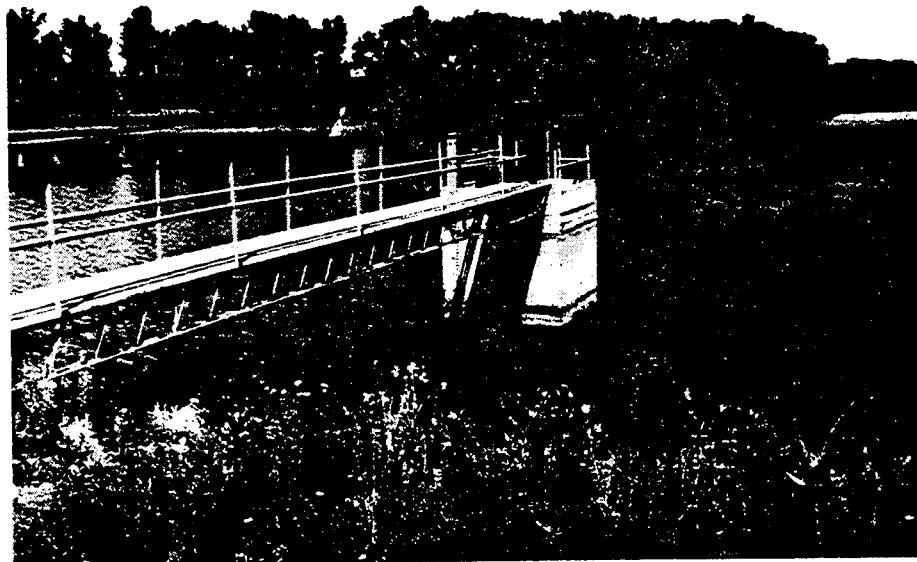
LOWER DERBY LAKE: General View
(Looking East)
Date of Photograph: 26 August 1982

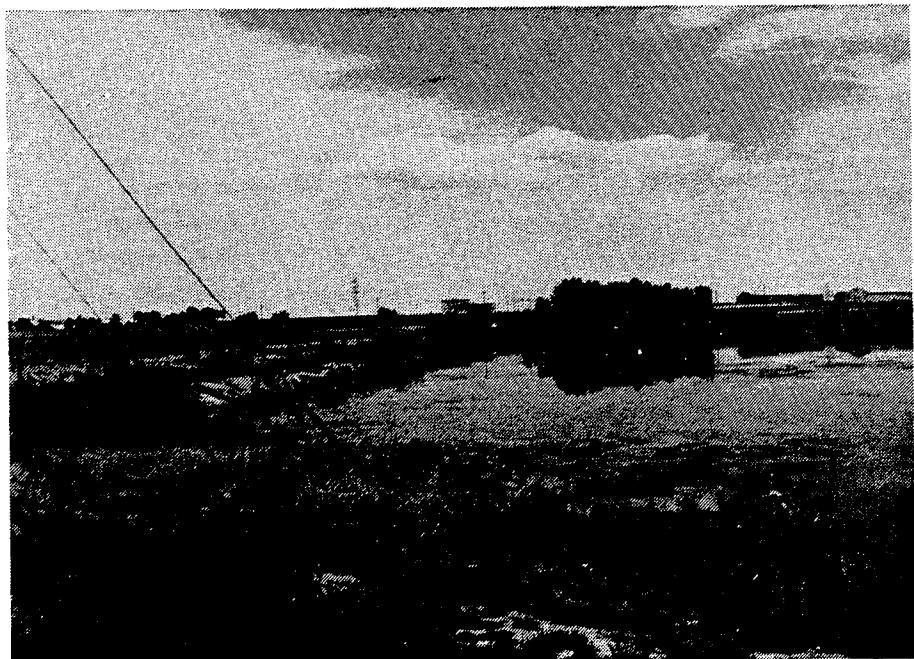
LADORA LAKE DIKE AND RIPRAP:
Looking South at West Side
Date of Photograph: 26 August 1982

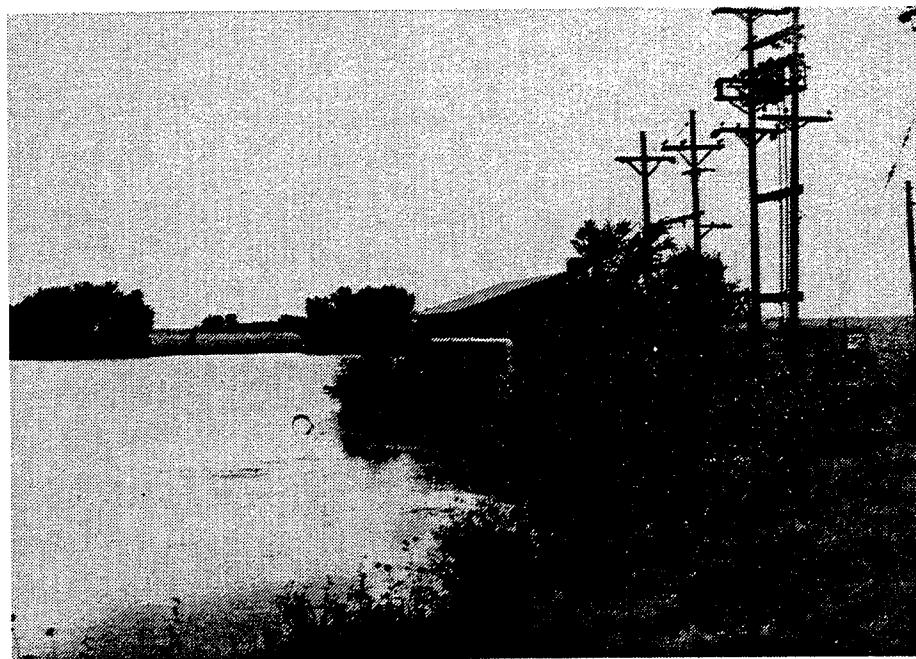
LADORA LAKE DIKE: Looking South
From Building No. 371.
Date of Photograph: 26 August 1982

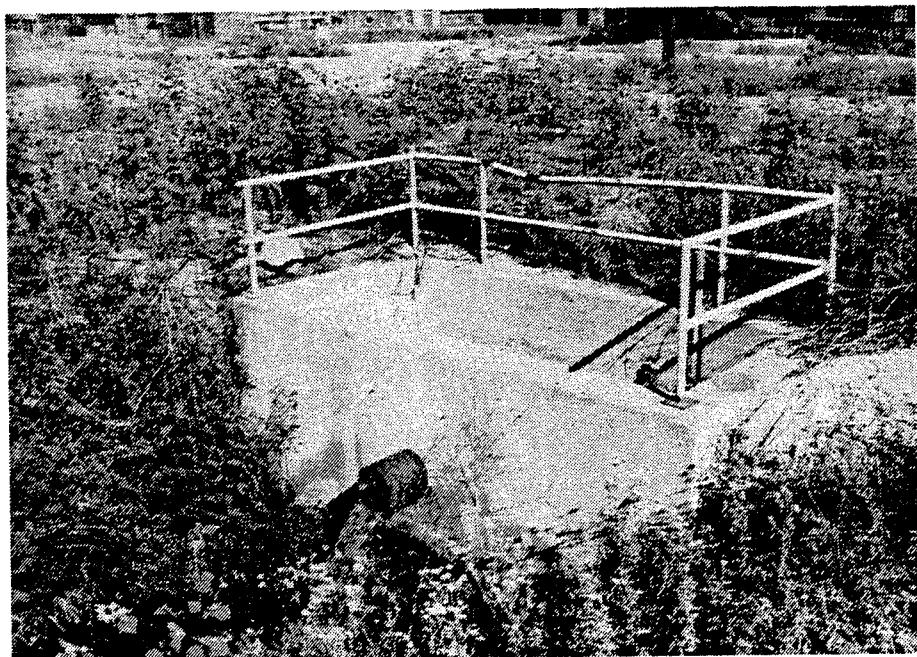
CONCRETE COLLECTING BOX: General
View (Near Building No. 548)
Date of Photograph: 31 August 1982

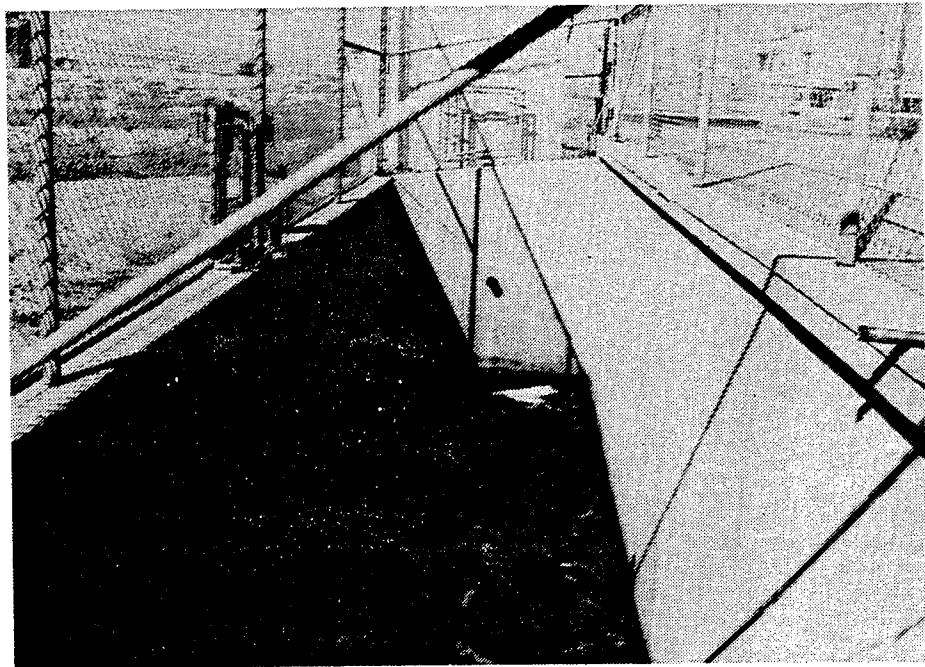
CONCRETE COLLECTING BOX: General View
(Near Building No. 548)
Date of Photograph: 31 August 1982

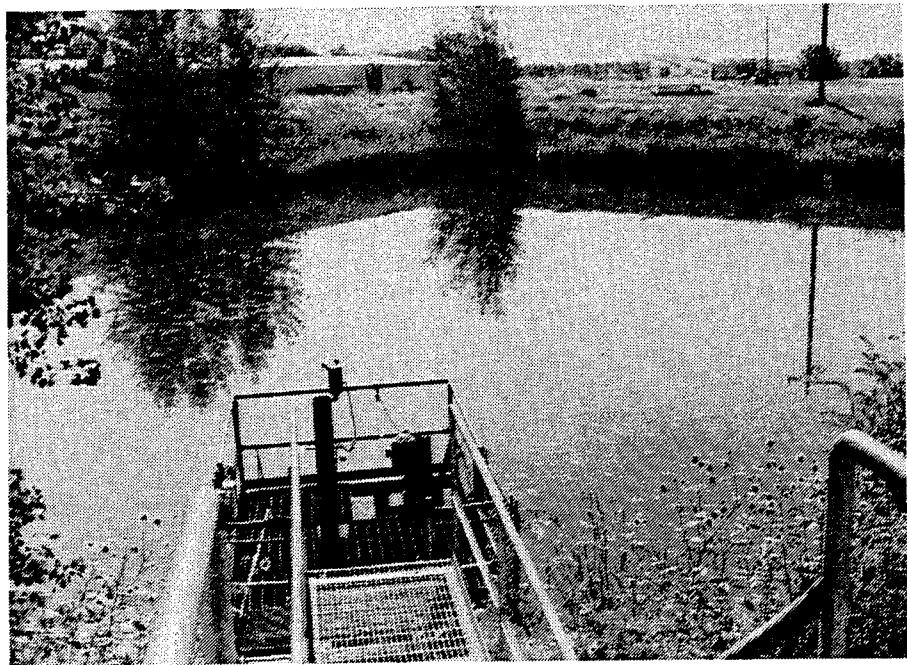
WET WELL: Adjacent to Pump Room
(Building No. 548)
Date of Photograph: 31 August 1982
